INDOOR AIR QUALITY ASSESSMENT

**Wilmington Memorial Library
175 Middlesex Avenue
Wilmington, Massachusetts**

Prepared by:
Massachusetts Department of Public Health
Bureau of Environmental Health Assessment
Emergency Response/Indoor Air Quality Program
December 2003

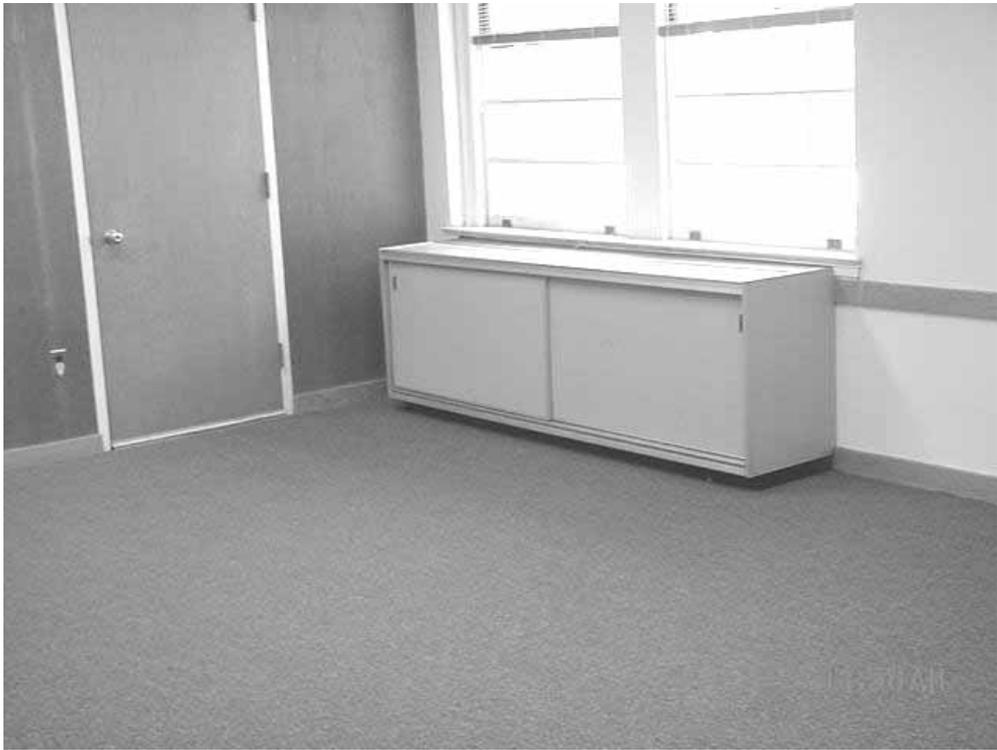
Picture 1

Fresh air is supplied by a unit ventilator (univent) system (Picture 1). Univents draw air from outdoors through fresh air intakes located on the exterior walls of the building (Picture 2) and return air through air intakes located at the base of each unit ([Figure 1](#)). Fresh and return air are mixed, filtered, heated/cooled and provided to occupied areas through an air diffuser located in the top of the unit. Obstructions to airflow, such as papers and books stored on univents and shrubbery and plant growth outside were seen in a number of areas (Pictures 2 & 3). In order for univents to provide fresh air as designed, intakes must remain free of obstructions and remain activated while the library is occupied.

Typical Unit Ventilator (Univent)

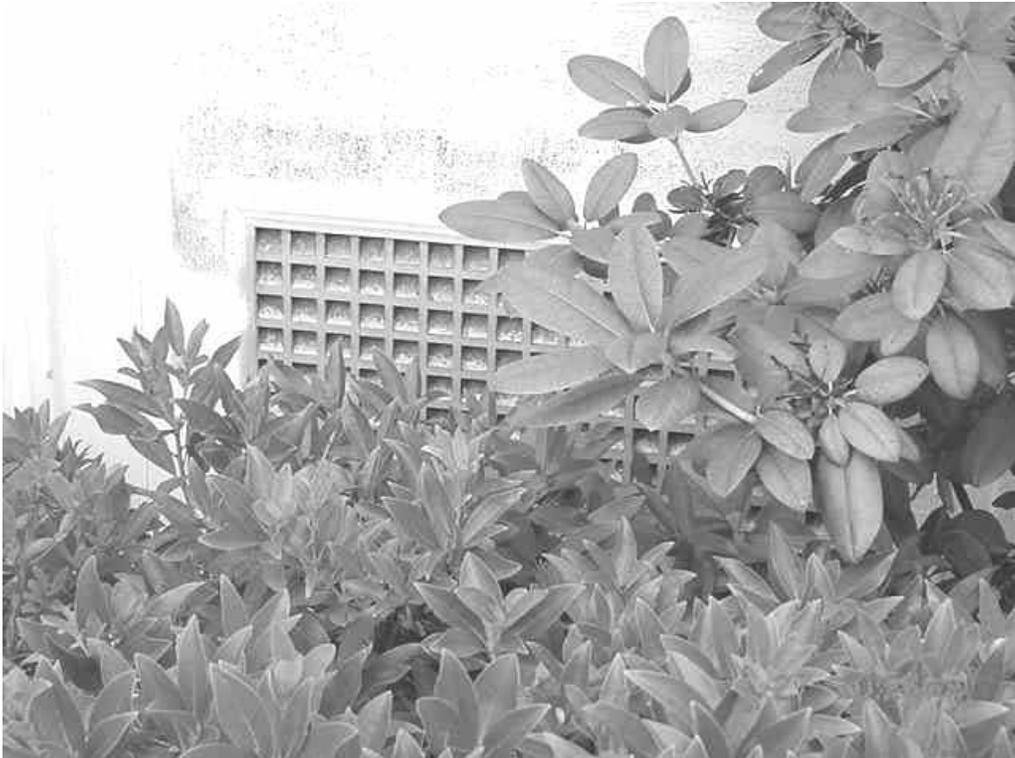
Picture 2

Univent Fresh Air Intake Obstructed by Shrubberty

4. Remove all blockages from univents and exhaust vents to ensure adequate airflow.
5. Ventilation industrial standards recommend that mechanical ventilation systems be balanced every five years (SMACNA, 1994). Consult a ventilation engineer concerning re-balancing of the ventilation systems.

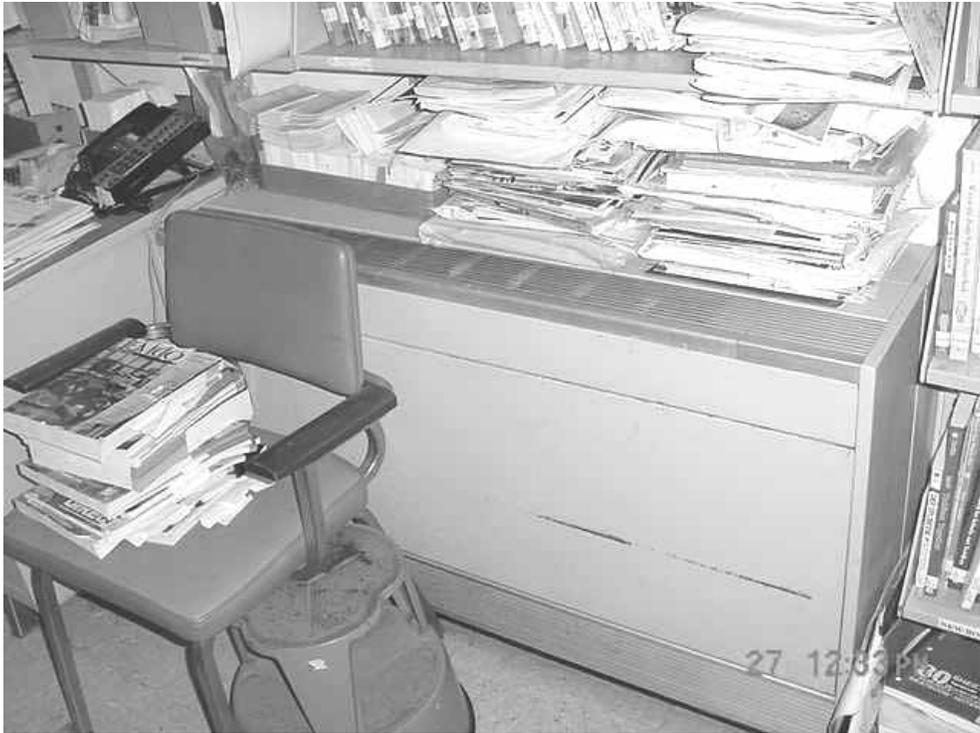
Picture 3

Items on and in Front of Univent

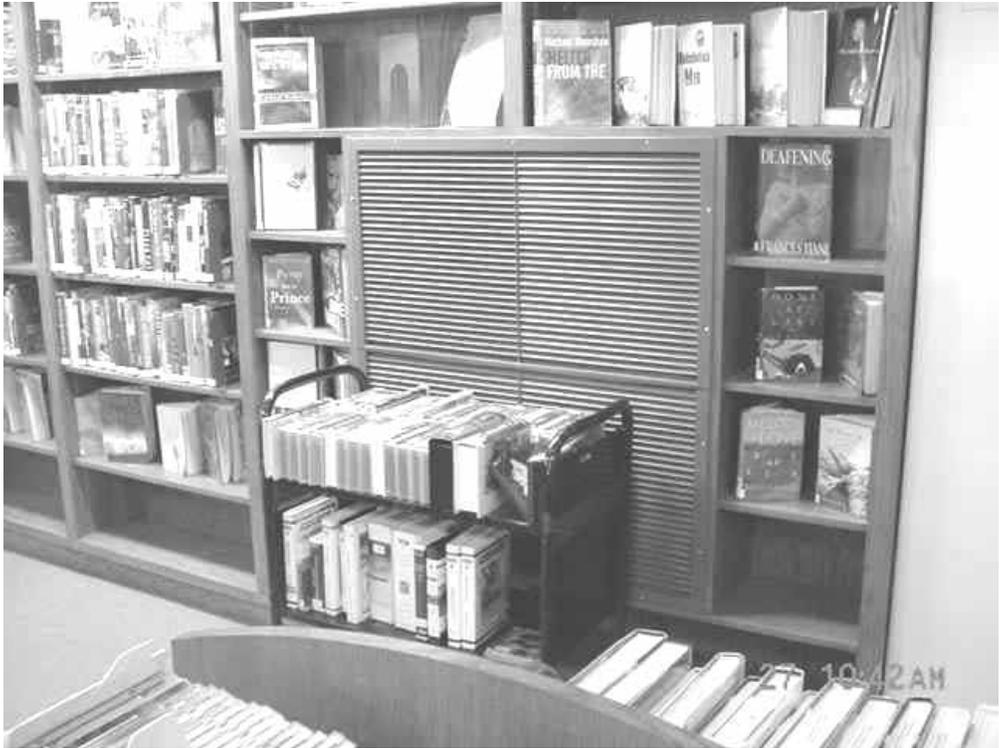
Picture 4

Exhaust ventilation is provided by wall and ceiling-mounted exhaust grilles (Picture 4). Exhaust vents are located in common areas throughout the building and are connected to rooftop motors via ductwork. Exhaust vents were operating during the assessment.

Wall Mounted Exhaust Vent

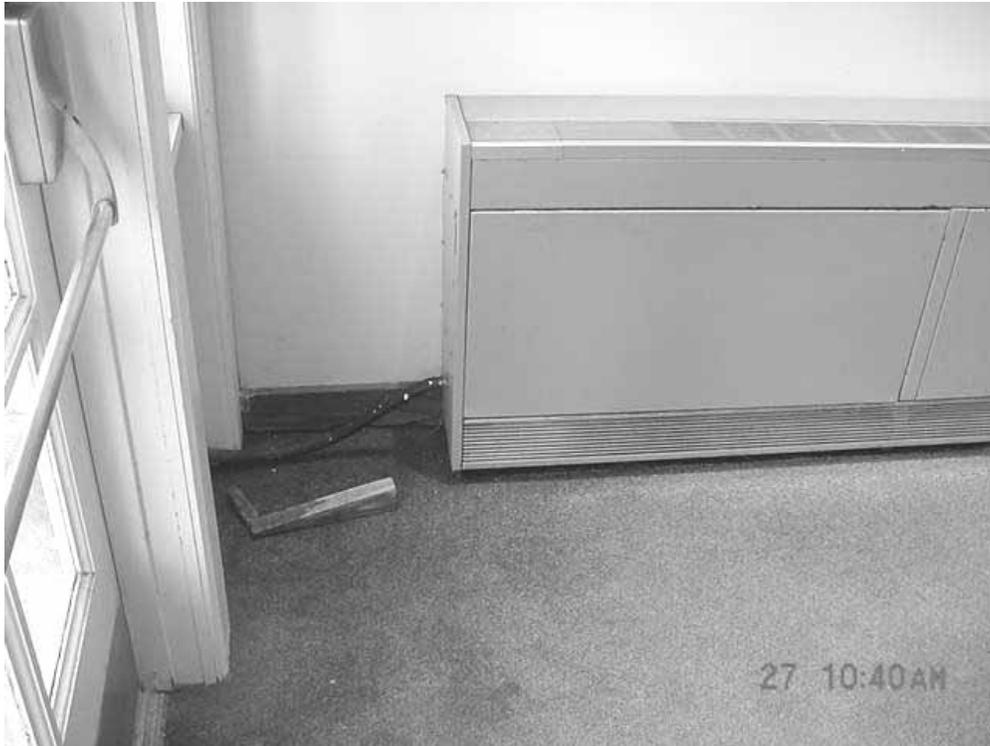
Picture 5

- Univents provide air conditioning during summer months. The univent chilled-water pipes are not insulated and therefore are prone to condensation. When warm, moist air passes over a cooler surface (e.g., pipes, metal components to univent cabinets), condensation is formed and collects on the cold surface. Water damaged carpeting around univents was observed in a number of areas throughout the building (Picture 5).

Water Damaged Carpeting (Corner) Near Univent in Front Foyer

7. Keep windows closed during hot, humid weather to maintain indoor temperatures and avoid condensation problems.
8. Insulate univent pipes to help prevent condensation.

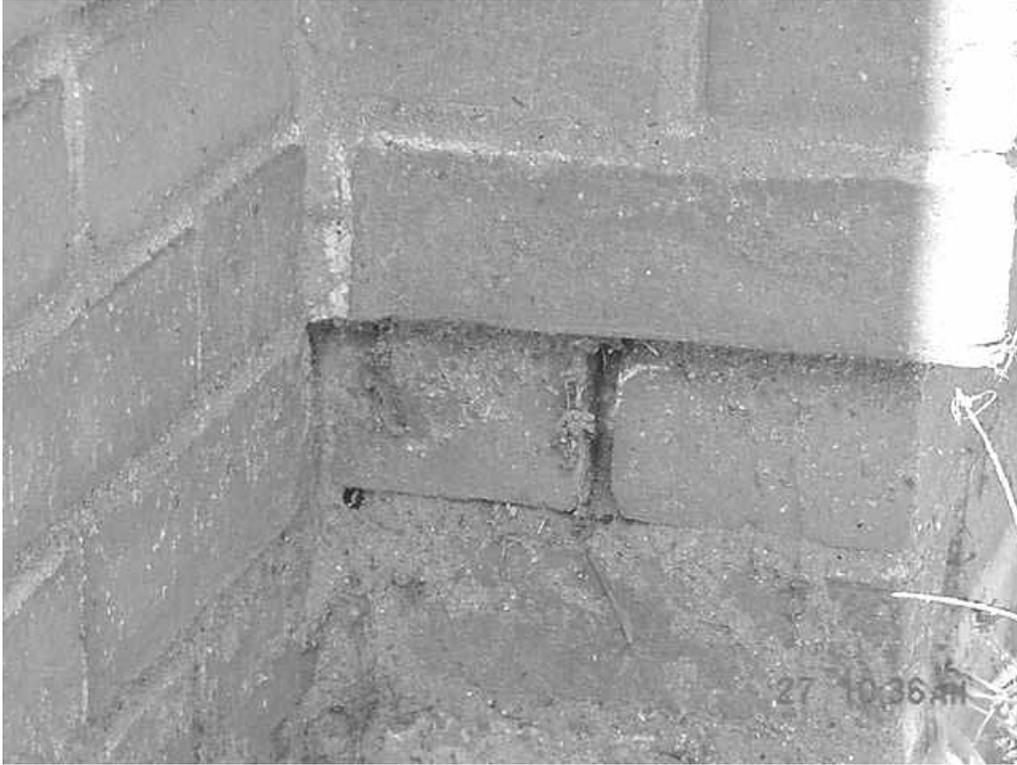
Picture 6

- Missing/damaged mortar around bricks and holes and spaces were observed in exterior walls (Pictures 6 & 7). Water damaged wall plaster was seen in several areas as a result of water penetration through these breaches in the building envelope (Picture 8).

Missing/Damaged Mortar around Brickwork

Examine the feasibility of repointing brickwork.

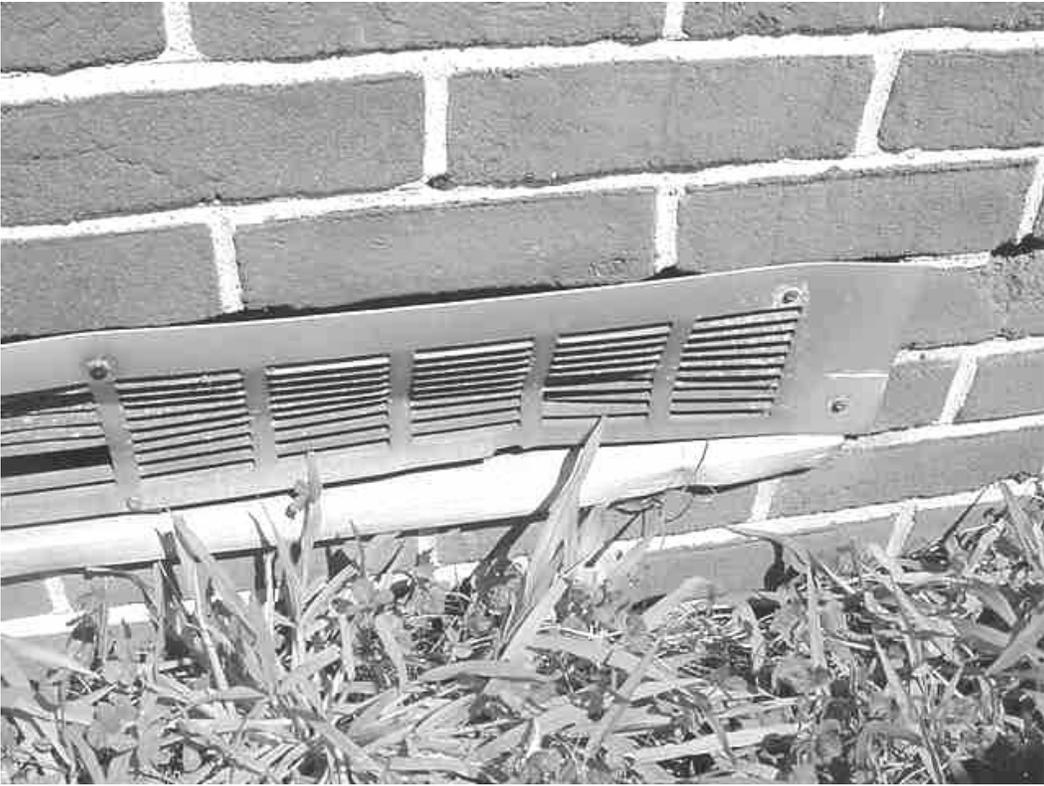
Picture 7

Spaces around Damaged Vent on Exterior Brick Wall

11. Repair dislodged/damaged gutters and downspouts. Replace elbow extensions to direct rainwater away from the foundation.
12. Seal open utility holes and spaces around vents on exterior of the building. Repair water damaged plaster on interior walls.

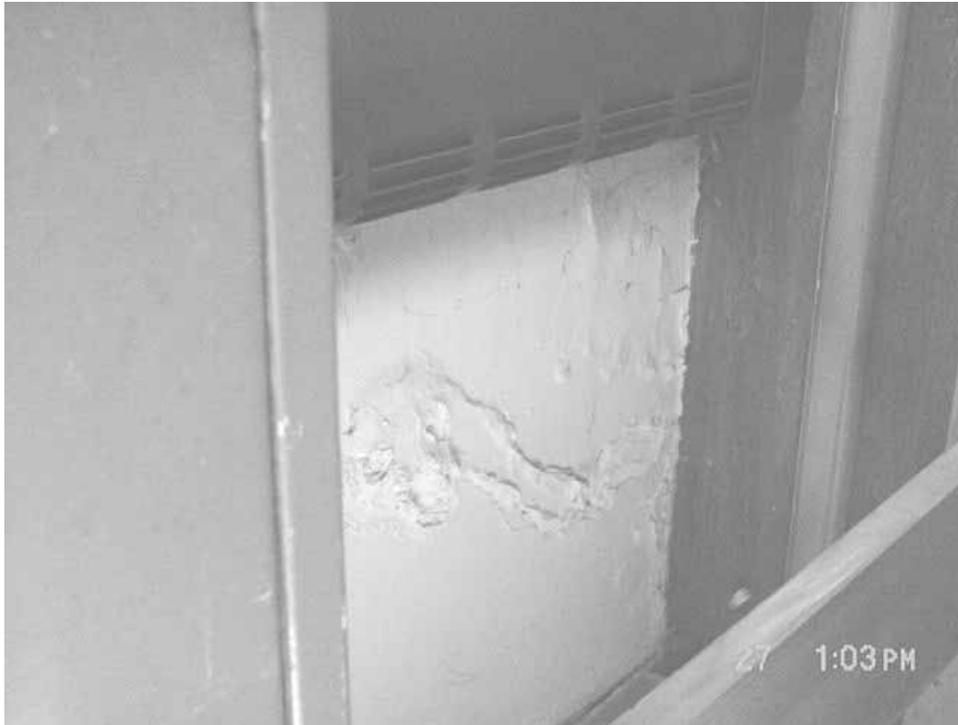
Picture 8

Water Damaged Wall Plaster in Technical Services Office, Note Wall Damage is Roughly Opposite Vent Shown in Picture 7

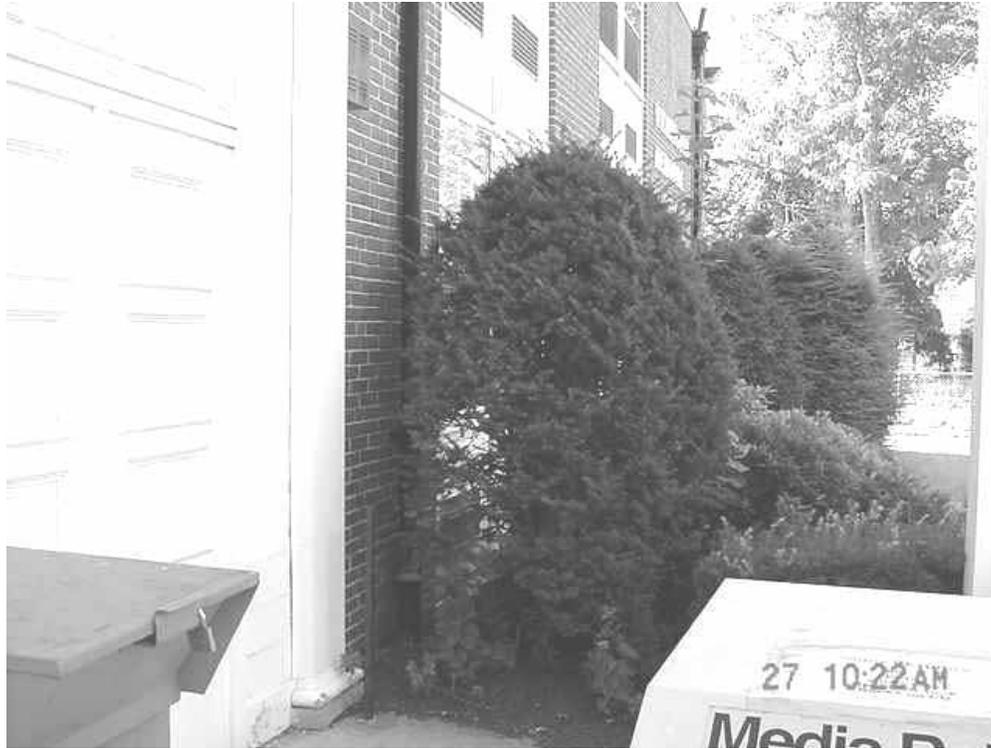
Picture 9

- Growth of small trees/stumps, and other plants were seen along the perimeter of the building (Picture 9). The growth of roots/plants against the foundation/exterior walls of the building can bring moisture in contact with wall brick and eventually lead to cracks and/or fissures in the foundation below ground level.

Shrubs and Plant Growth Against the Exterior of the Building

9. Remove plants or relocate approximately five feet away from the exterior wall of the building to prevent water impingement.
10. Ensure all roof leaks are repaired. Repair/replace missing/damaged flashing along roof. Replace any remaining water-stained ceiling tiles. Examine the areas above and around these tiles for mold growth. Disinfect areas of water leaks with an appropriate antimicrobial.

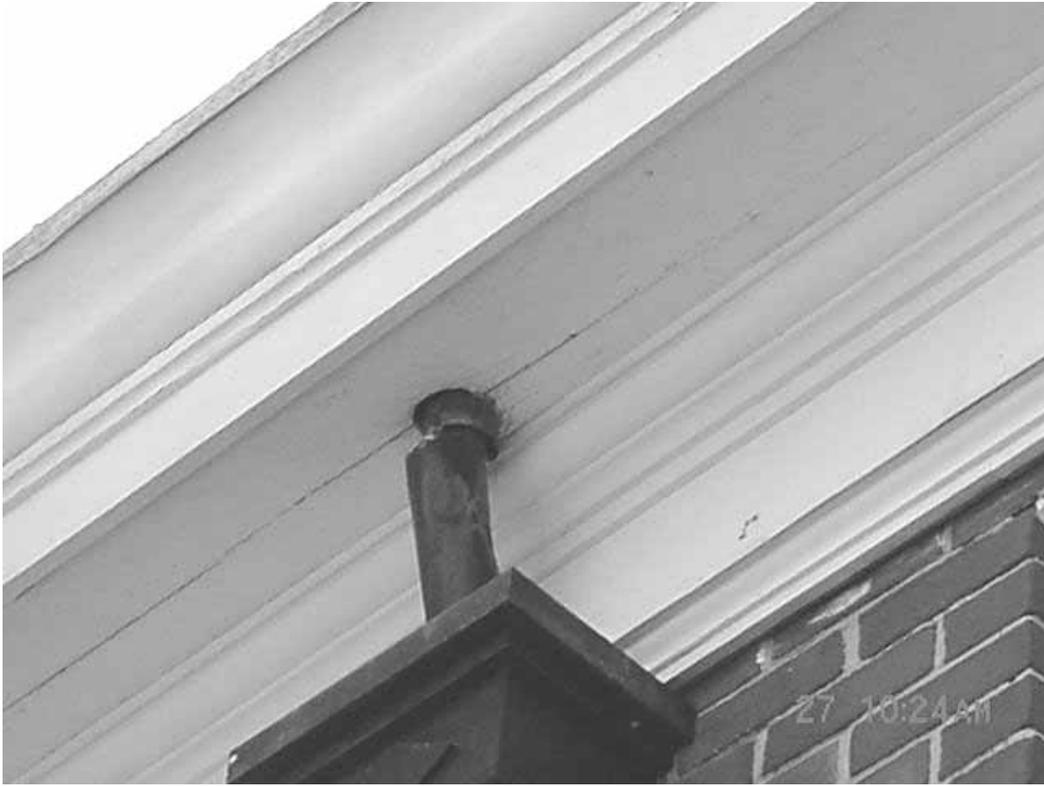
Picture 10

- Missing/damaged gutters and downspouts were seen in several areas (Picture 10 & 11). Gutters and downspouts are designed to direct rainwater away from the base of the exterior walls. In some cases the gutter/downspout system empties water directly against the foundation (Picture 12). These conditions can undermine the integrity of the building envelope and provide a means of water entry into the building through foundation concrete and masonry by capillary action (Lstiburek & Brennan, 2001).

Dislodged Downspout along Roof of Building

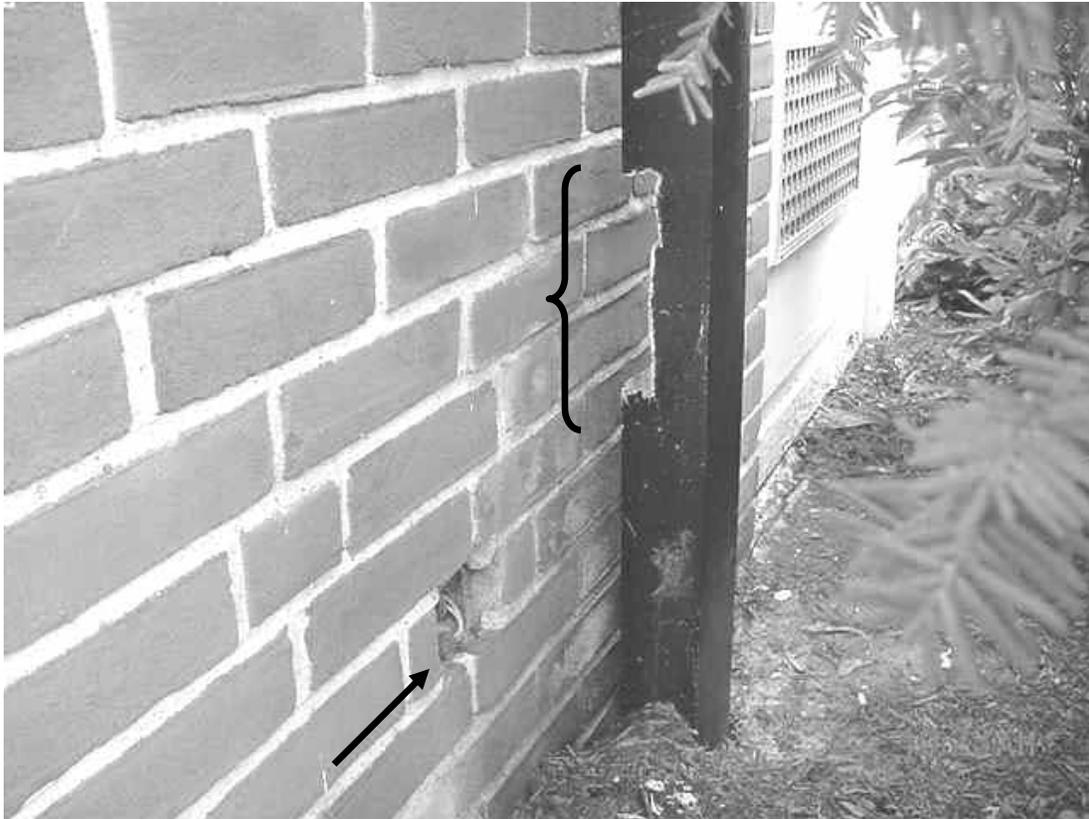
Picture 11

Open Electrical Outlet (Utility Hole) and Downspout With Portion Cut Out, Note Moss Growth was Seen on the Brick Opposite Hole in Downspout

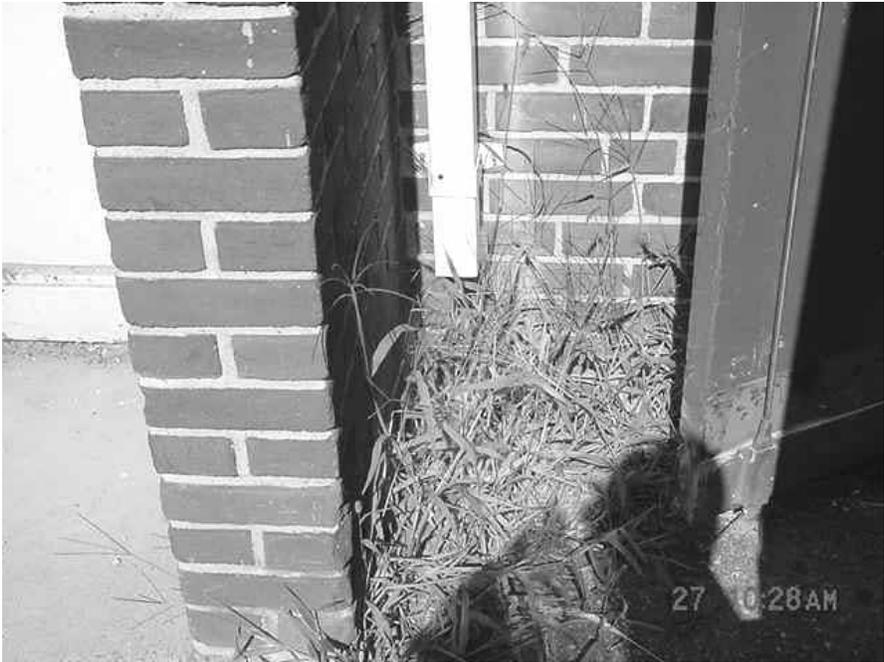
Picture 12

Downspout Missing Elbow at Base

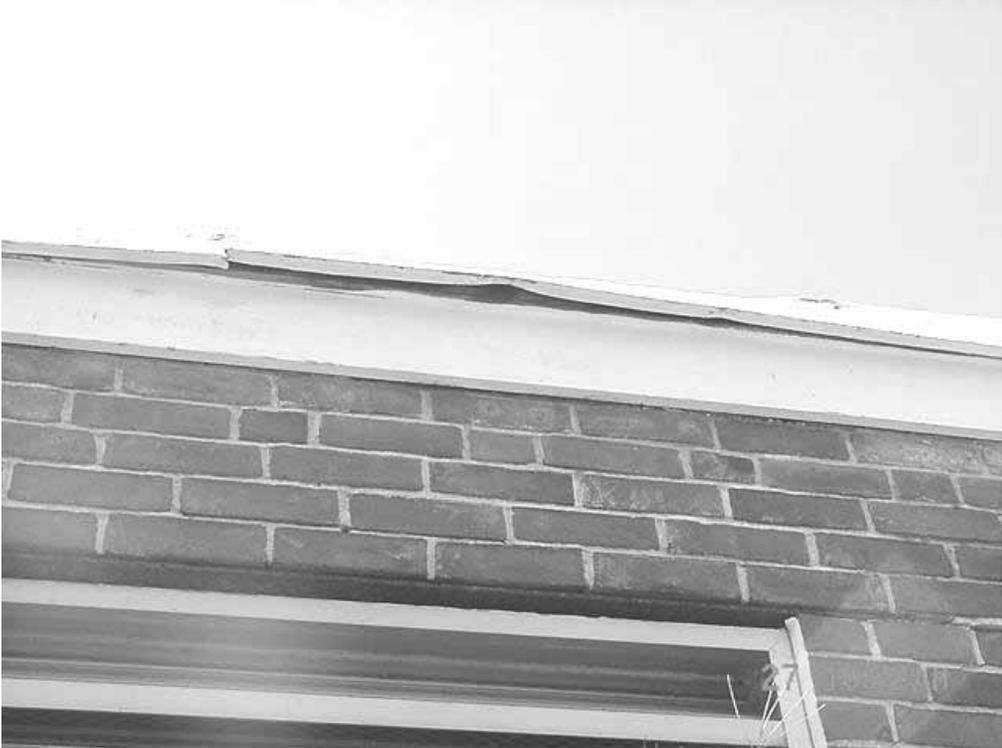
- Picture 13 shows an area on the exterior of the building where flashing is missing/damaged.

Damaged Flashing Along Roof

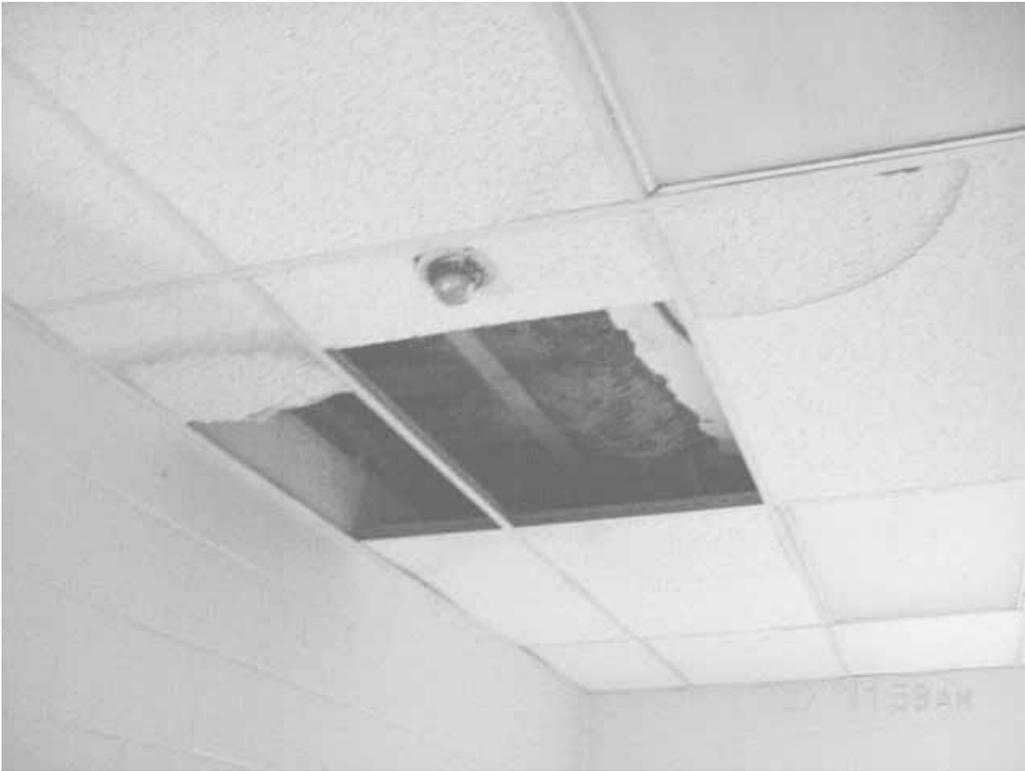
Picture 14

- A number of areas had missing and/or water-damaged ceiling tiles (Picture 14), which is evidence of a roof or plumbing leak. Occupants reported that the roof leak had been repaired and no active leaks were present at the time of the assessment. Water-damaged ceiling tiles can provide a source of mold growth and should be replaced after a water leak is discovered and repaired.

Missing/Water Damaged Ceiling Tiles

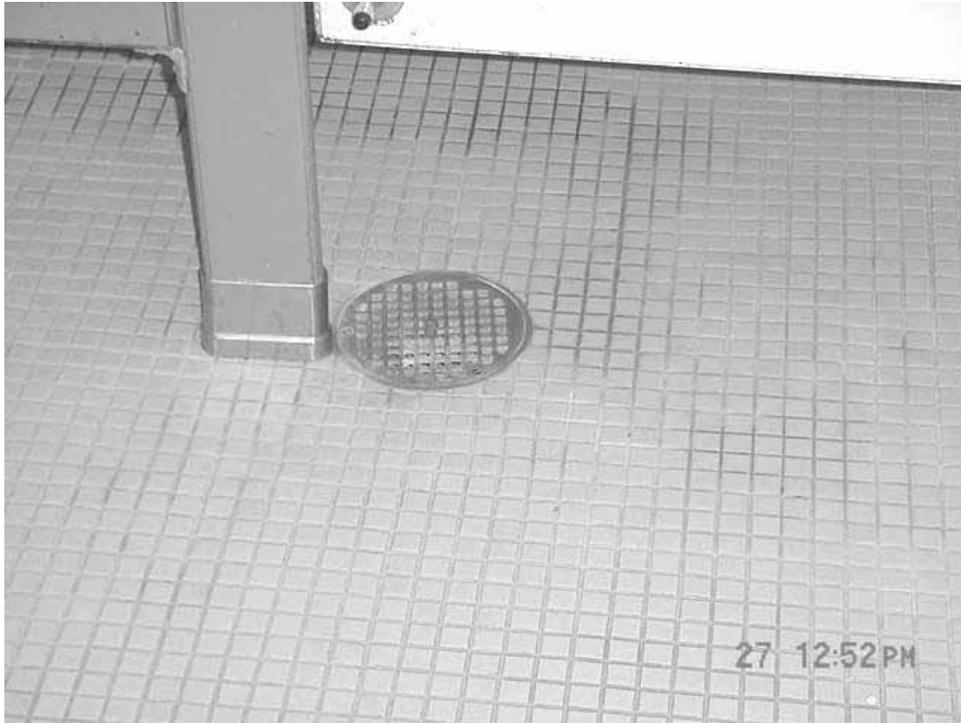
Picture 15

Periodic sewer gas odors were reported in the second floor restrooms. Restrooms are equipped with floor drains (Picture 15). Drains are designed with traps in order to prevent sewer odors/gases from penetrating into occupied spaces. When water enters a drain, the trap fills and forms a watertight seal. Without periodic input of water (e.g., 2-3 times per week), traps can dry and compromise the integrity of the watertight seal. If traps dry out, sewer odors/gases can travel up the drain into occupied areas.

Typical Floor Drain in Restroom

13. Pour water down floor drains in restrooms regularly (e.g., 2 to 3 times a week) to prevent sewer gas back up.
14. For further building-wide evaluations and advice on maintaining public buildings, see the resource manual and other related indoor air quality documents located on the MDPH's website at <http://www.state.ma.us/dph/beha/iaq/iaqhome.htm>.
